# Manhole Inspection Summary

Manhole # S25M\_\_013MH

**Location** Address: **1300 Sargent Street**

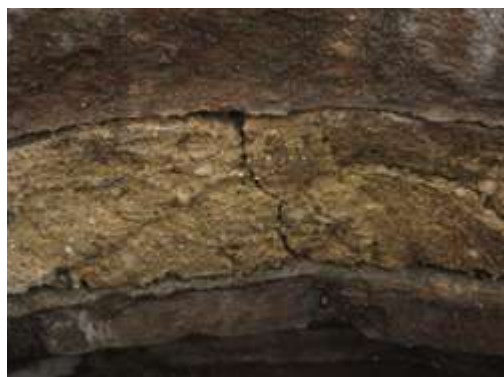
Defect 5

cracked mortar on chimney

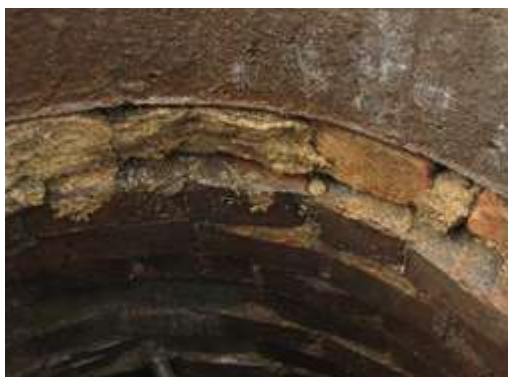
Defect 4

Infiltration: ☐ None ☐ Joint ☐ Cracks ☒ **Mortar** ☐ Roots ☒ **Wall**

infiltration from chimney at mortar & wall

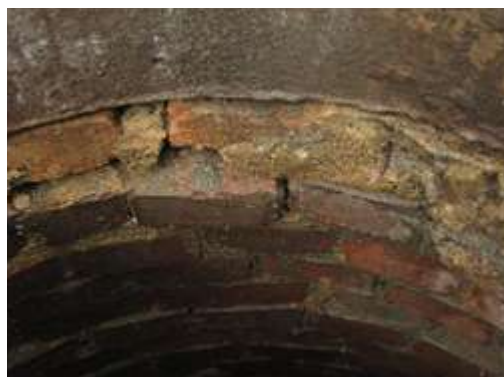
Defect 2

Condition: ☐ Sound ☐ Cracked ☐ Root Intrusion ☒ **Loose Brick** ☐ Deteriorated

chimney loose/missing mortar & bricks

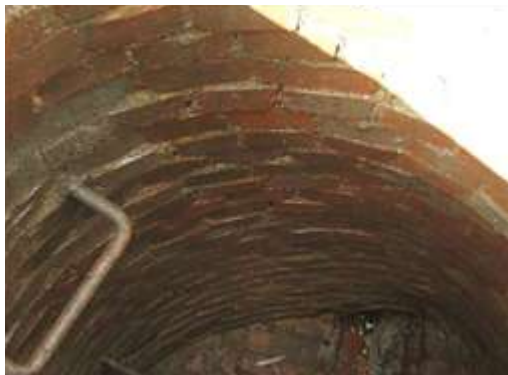
Defect 1

signs of infiltration on barrel and corbel at walls

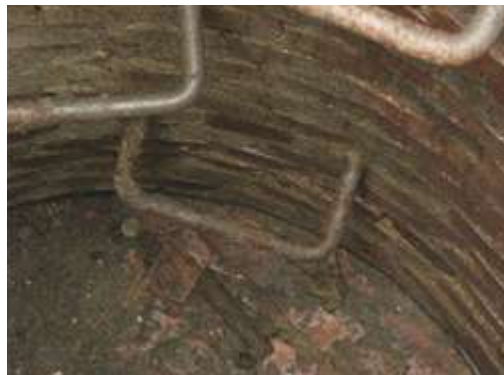
**Steps** Count: **4** Missing: **0** ☒ **Corroded**

Corroded steps

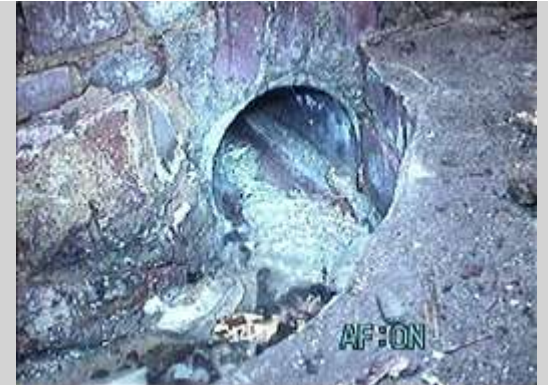
12 O'Clock Outflow

8 in. Circular Gravity Sewer  
Pipe Out @ 12 OClock

Pipe Height: **8.4** (in.) Rod and Bar (Angled)  
Pipe Material: **Clay** ☐ Pipe Lined  
Invert Depth: **7.33** (ft.) Flow Characteristics: **Slow**  
Deposits: ☐ None ☐ Mud ☐ Sludge ☒ **Debris** ☐ Grease  
Silt Depth: **0.5** (in.) Deposits Extent: **Light**  
Infiltration: **None** Pipe Seal Cond: **Sound**

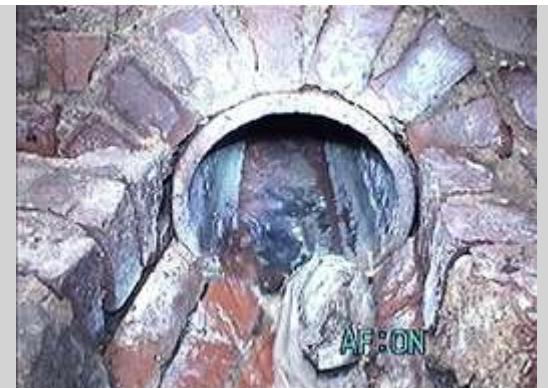
9 O'Clock Inflow

8 in. Circular Gravity Sewer  
Pipe In @ 9 OClock

Pipe Height: **8.4** (in.) Rod and Bar (Angled)  
Pipe Material: **Clay** ☐ Pipe Lined  
Invert Depth: **7.04** (ft.) Flow Characteristics: **Slow**  
Deposits: ☐ None ☐ Mud ☐ Sludge ☒ **Debris** ☐ Grease  
Silt Depth: **0.25** (in.) Deposits Extent: **Light**  
Infiltration: **None** Pipe Seal Cond: **Sound**
